PVP2010-26131

**WATER HAMMER AND COLUMN SEPARATION DUE TO ACCIDENTAL
SIMULTANEOUS CLOSURE OF CONTROL VALVES IN A LARGE SCALE TWO-
PHASE FLOW EXPERIMENTAL TEST RIG**

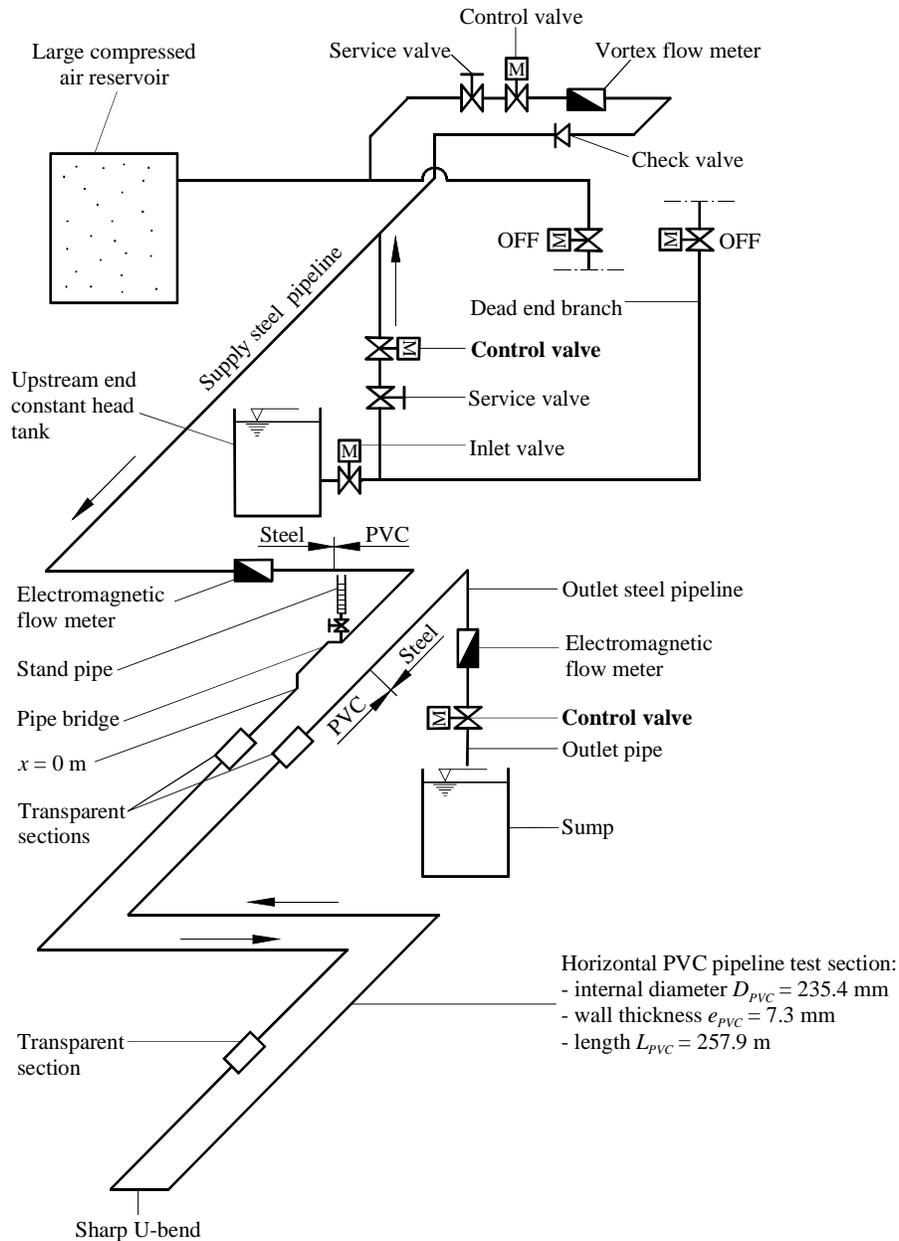
Figure 1: Dynamic two-phase flow test rig at Deltares, The Netherlands.

The dynamic two-phase flow test rig at Deltares, Delft, The Netherlands has been used for pipeline filling and emptying experiments. Due to the limited capacities of water tank and compressed-air reservoir the original industrial size 250 mm nominal diameter horizontal PVC pipeline test section was shortened from 600 m to 258 m. The water was supplied from a 25 m constant head tank through a supply steel pipeline and PVC pipe bridge to the PVC pipe test section (see Fig. 1). The compressed-air reservoir (volume of about 70 m^3) provided the

The accident occurred during steady flow trial and error tests by unintentional closure of the automatically operated control valves at the upstream-end constant-head tank and at the outlet of the PVC pipe test section (see Fig. 1). It has been found afterwards that void fraction and water level remained nearly constant during the accidental event (no void, pipe full of water) and these will not be considered in this paper. The air supply line was at atmospheric pressure during the accident. The quantities that significantly changed were the automatically operated butterfly valve position signals, water pressures and water flow rates. The layout of the instruments that recorded these dynamic quantities is depicted in Fig. 2.

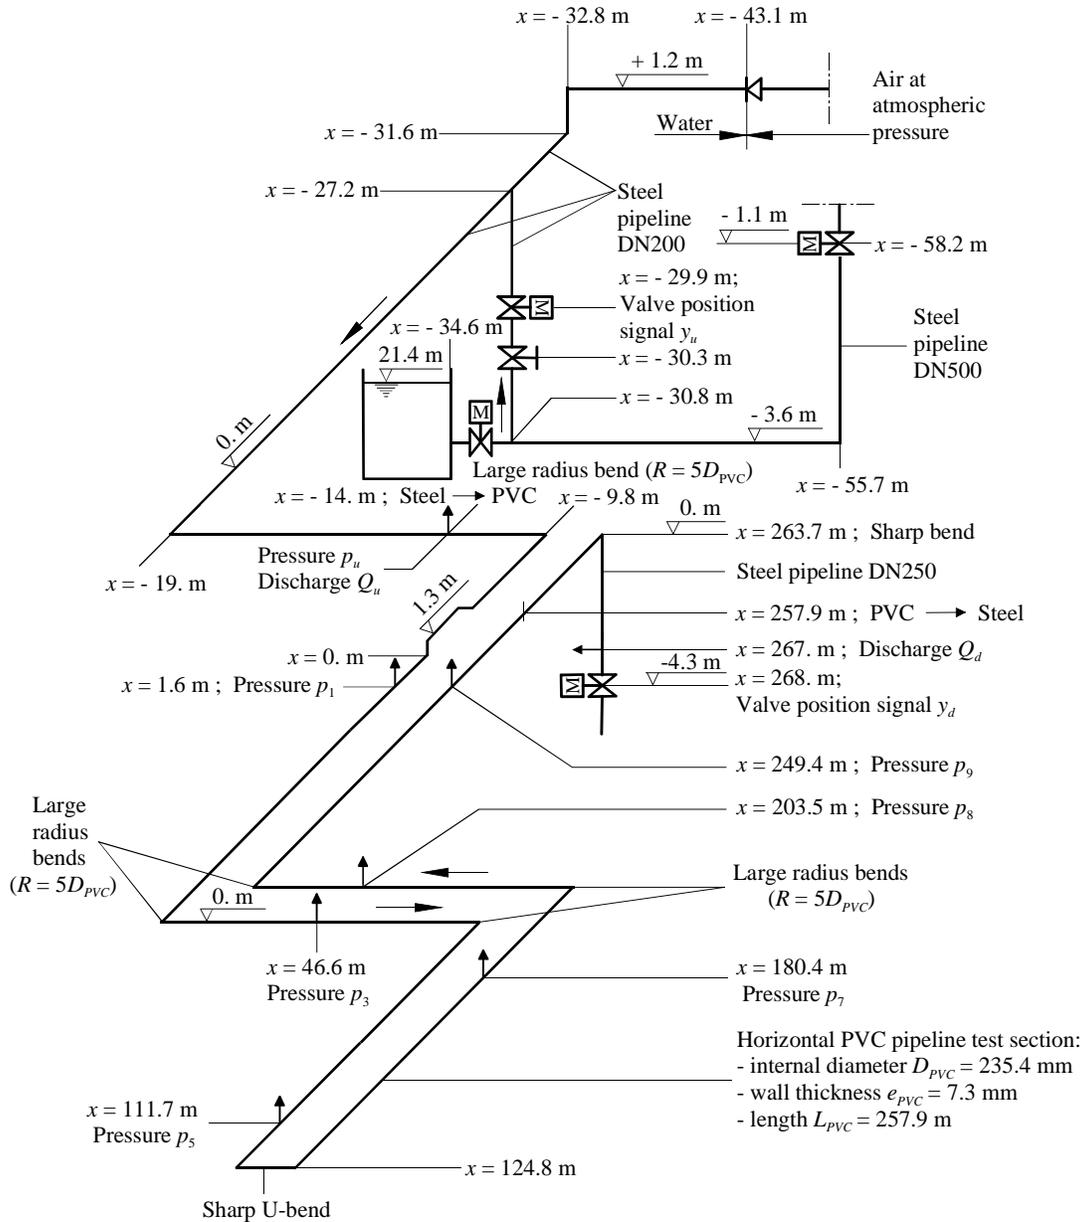
Figure 2: Layout of dynamic instruments in water supply steel pipe system and PVC pipe test section for influential quantities during accidental event.

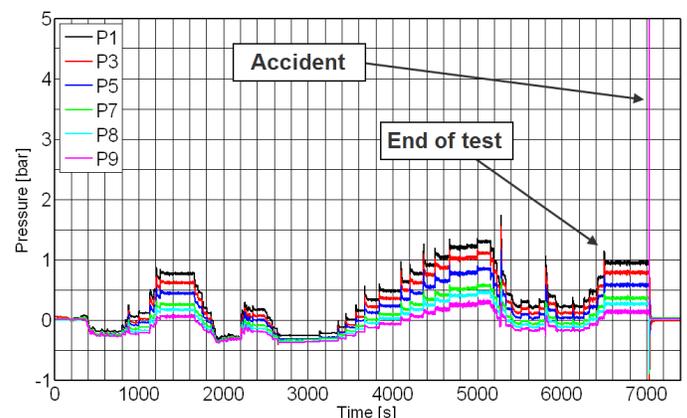
Figure 3: Pressure history at different positions along the PVC pipeline during testing and accident.

The performance of the newly installed upstream-end automatic pressure-control valve needed to be tested. For this reason the researchers started with gradually changing the pressure set-point on the control panel (up and down) thereby waiting for the initiated transient to damp out into steady state flow in the PVC pipeline (Figure 3). At all times during the testing the group focused on stability and reliability of the automatic upstream-valve performance. Because the experimental test rig was designed for two-phase flow experiments, and not for water hammer tests, the pressure jumps during all tests were moderate and there was no speak of any significant pressure surge (Fig. 3). As the pressure set-point testing was not part of the experimental programme, the

sampling rate was reduced to 20 Hz, which was sufficient for its purpose, and - as it turned out later - it was just high enough to catch the unintentional water-hammer accident. It turned out that the performance of the upstream-end automatic control-valve was reliable and stable. The testing successfully ended after 6500 seconds and then the team members were gathered in the control room to discuss new settings for the second series of experimental measurements (all authors were present except the last co-author). The second series concerned controlled emptying of the PVC pipeline; therefore, the flow rate through the piping system of about 145 litres per second was maintained and not interrupted. Figure 3 indicates that the accident happened approximately after 7000 seconds of testing.

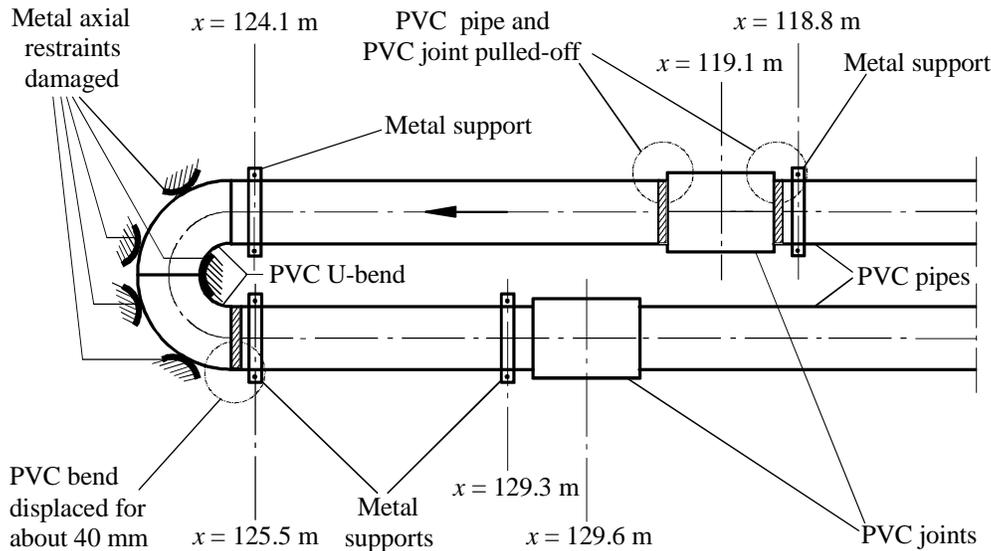
Figure 4: Overview of damages at the sharp U-bend of the PVC pipeline test section.

(1) *Description of damages at the sharp U-bend (Figs. 4 and 5):* The U-bend was clamped with two metal supports at $x = 124.1$ m and $x = 125.5$ m and five metal axial restraints (steel hollow cylinders bolted to the concrete floor) which prevented movement in horizontal direction. During the accident, the forces on the supports were so large that four metal axial restraints were pushed away while the fifth axial restraint got entirely loose and fell away from the U-bend (screws were cut-off at the floor plane). Photograph Fig. 5b shows a damaged metal axial restraint (bolting screws were partly pulled-out and the steel column was inclined). The downstream joint of the PVC U-bend at $x = 125.2$ m displaced for about 40 mm and a small leakage was observed here. The axial movement of the U-bend resulted also in the partial opening of the PVC pipe in the joint at the distance $x = 119.1$ m (Fig. 5a). This was possible because the metal support at 124.1 m enabled axial displacement of the PVC pipe for 35 mm. However, no leakage was detected at this joint. No visible damages were detected at the metal supports (brackets) at $x = 118.8$ m and upstream, and at the metal supports at $x = 125.5$ m and downstream.

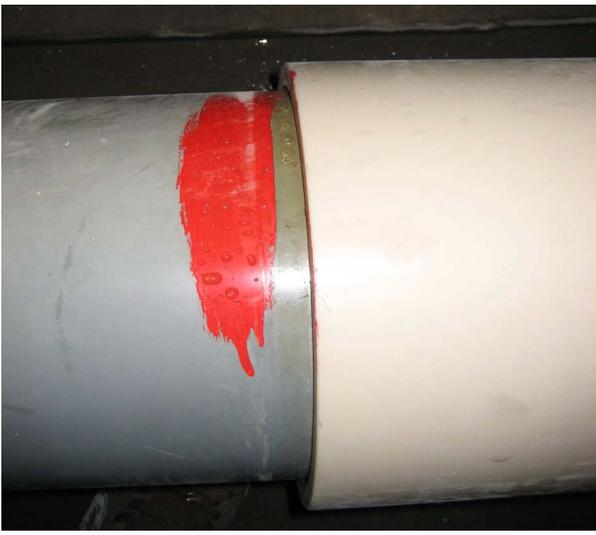
a) Damaged PVC pipe joint at distance $x = 119.1$ m.

Figure 5: Damages at the sharp U- bend of the PVC pipeline test section.

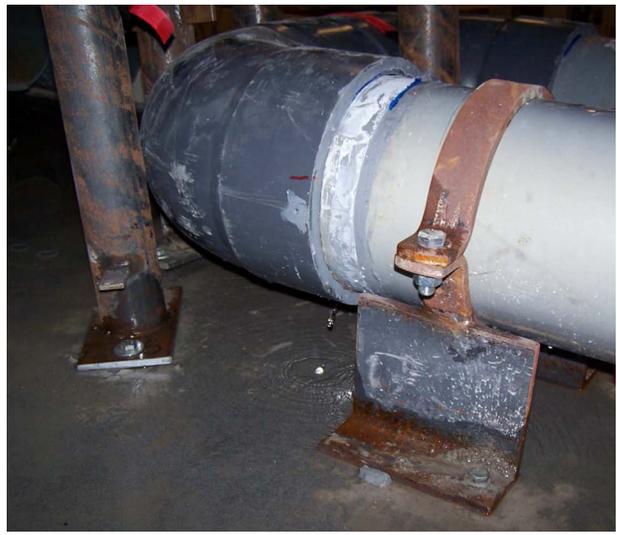
b) Damaged PVC U-bend at distance $x = 125.5$ m.

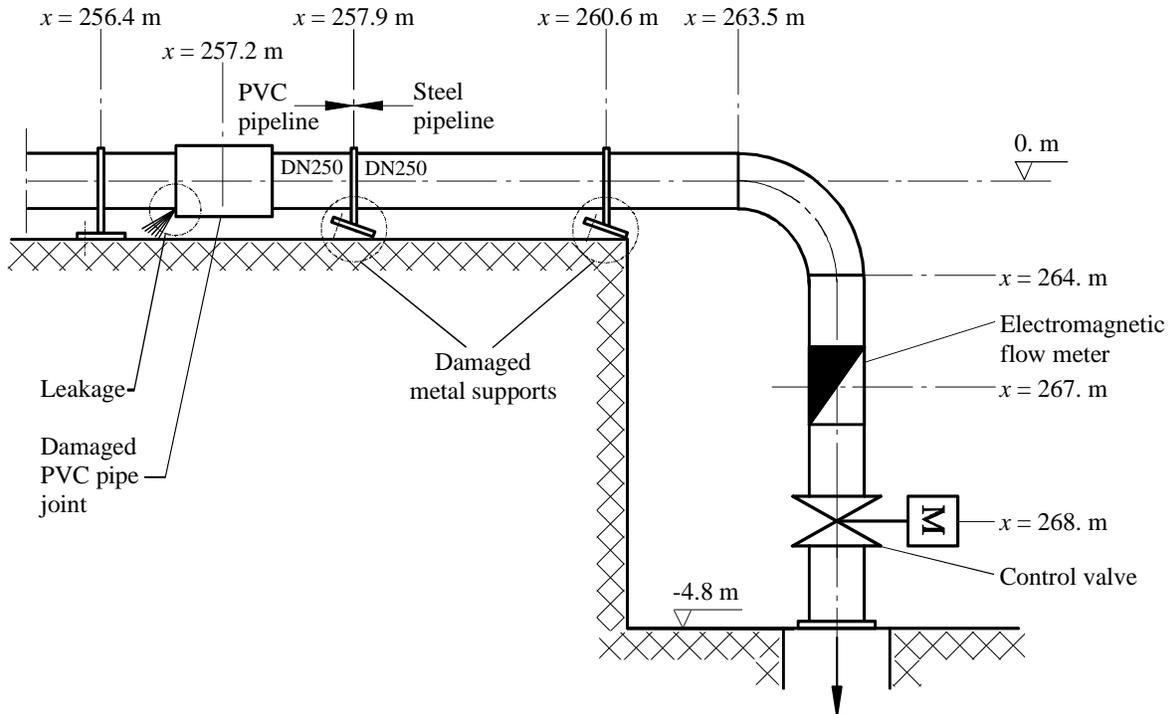
Figure 6: Overview of damages at the outlet of the horizontal PVC pipeline test section.

(2) *Description of damages at the outlet side of the horizontal PVC pipeline test section (Figs. 6 and 7):* The PVC pipeline was located on the balcony of the laboratory (first floor) and a steel pipe section with sharp downward 90° elbow was used to divert water into the sump (ground floor). The connection between PVC and steel pipeline was at $x = 257.9$ m, and the downward elbow was at position $x = 263.5$ m. The vertical part of the steel pipeline was supported by a steel structure and was free to move in the horizontal plane and in vertical direction (up). The horizontal part of the steel pipeline was clamped with two metal supports at $x = 257.9$ m and $x = 260.6$ m. When the pressure upsurge was travelling through the downward elbow, the steel pipeline was lifted-up and away from the PVC pipeline. The steel pipe itself was undamaged but the metal supports were deformed as it is evident from Figs. 6 and 7. Figure 7 shows that some of the bolts anchoring the metal supports (brackets at $x = 257.9$ m and $x = 260.6$ m) to the concrete floor were damaged. Then the PVC pipe joint at $x = 257.2$ m opened and a large water leakage occurred (Fig. 7a). The pipeline upstream of the undamaged metal support at $x = 256.4$ m was left intact up to the metal support at $x = 125.5$ m (Fig. 4). No damages were detected at the electromagnetic flow meter and the control valve.

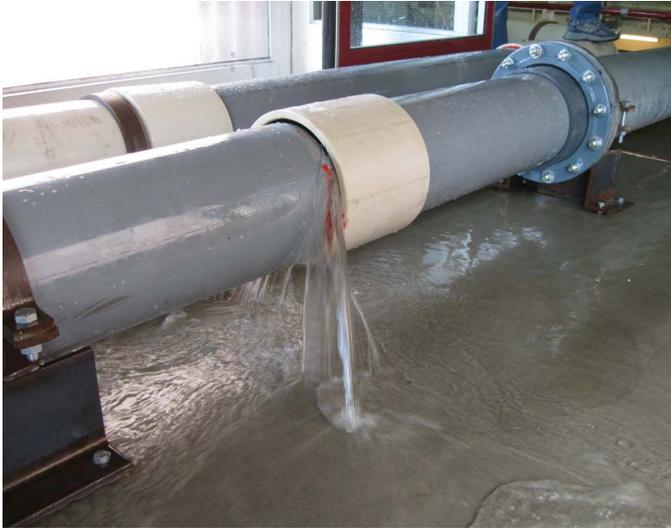
a) Leakage from damaged PVC pipe joint at distance $x = 257.2$ m.

Figure 7: Damages at the outlet side of the horizontal PVC pipeline test section.

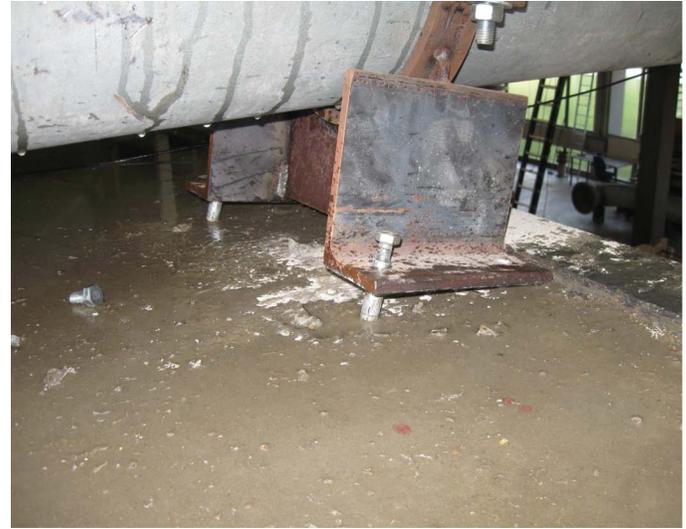
b) Damaged metal anchor at distance $x = 260.6$ m.

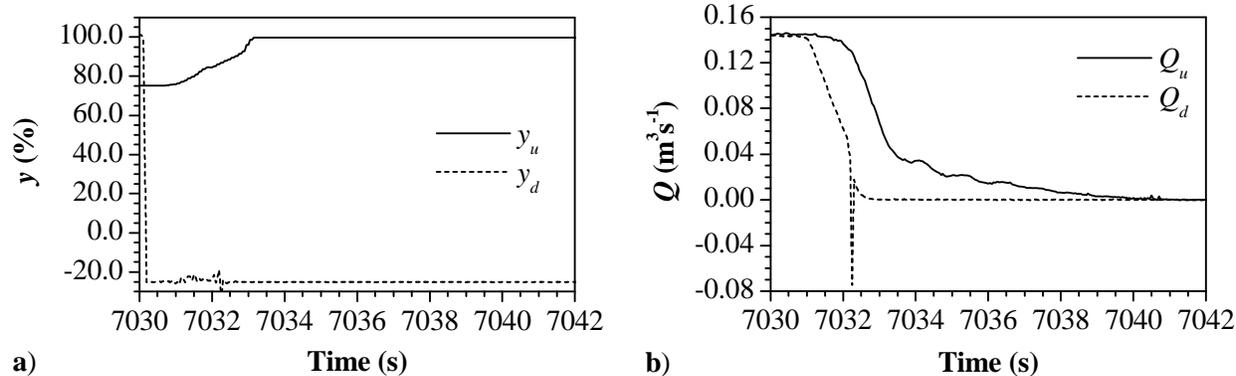
Before the accident, the DN150 upstream-end automatic valve was opened 75% and the DN150 downstream-end automatic valve was opened 100% and these settings corresponded to an initial flow rate in the piping system of $Q = 0.145$ m³/s with an upstream gauge pressure of $p_u = 1.01$ bar. Figure 8 shows the position signals y of the automatically operated control valves together with the upstream and downstream flow rates Q during the accidental event. The position signals were wired from computer via a volt-current converter to the control-valve actuators. The position signal of the downstream control valve y_d was set to a constant value (full opening) whereas the position signal of the upstream control valve y_u was controlled by computer in order to maintain a desired upstream pressure p_u set-point. The observed signals in Fig. 8a were taken as follows: (1) y_u was captured between the computer and volt-current converter and (2) y_d was captured between the volt-current converter and the valve actuator. A sudden drop of the signal y_d to -25% occurred at a test time of about 7030.2 seconds (see Fig. 8a). Because both control valves were wired to the same volt-current converter this time can be considered as the time at which the control valves started to close. However, the position signal y_u of the upstream control valve shows adjustment of the valve opening to its maximal opening at a time of about 7033 seconds (see Fig. 8a). This difference is because the position signal y_u was taken in between the computer and the volt-current converter.

Figure 8: Automatically-operated control valve position signals (y) and water flow rates (Q) during the accidental event.

The consequent change of upstream and downstream flow rates is even more peculiar (Fig. 8b). The downstream flow meter detects the first change of Q_d at time of 7030.7 seconds and the flow is stopped at time of 7033 seconds. The upstream flow meter detects the first change of Q_u at the time of 7031.5 seconds and the flow is stopped at the time of 7041 seconds. The different timing of flow changes may be attributed to different responses of the valve actuators to the accidental loss of the signal and to different flow conditions (boundary conditions). It should be noted that the distance between the upstream control valve and the upstream flow meter was about 16 metres with a pipe branch in between, whereas the distance between the downstream control valve and the downstream flow meter was only one metre (Figs. 1 and 2).

We may conclude that the incident was caused by a fault in an electronic conversion box due to power failure and this led to the actual closure of both automatic control valves as it is clear from the flow rate (Fig. 8b) and pressure traces (Fig. 9). The short power failure damaged the volt-current converter which sent signals to the valve actuators. Both valve actuators were motorized and 1 mA converter output corresponded to closed positions of the valves (the current converter box should always supply a current in the range 1 mA to 5 mA). Immediately after the accident a technician measured an output at the converter of 0 mA, indicating that the current converter box had broken down. This confirmed that in the case of loss of signal the valves close.

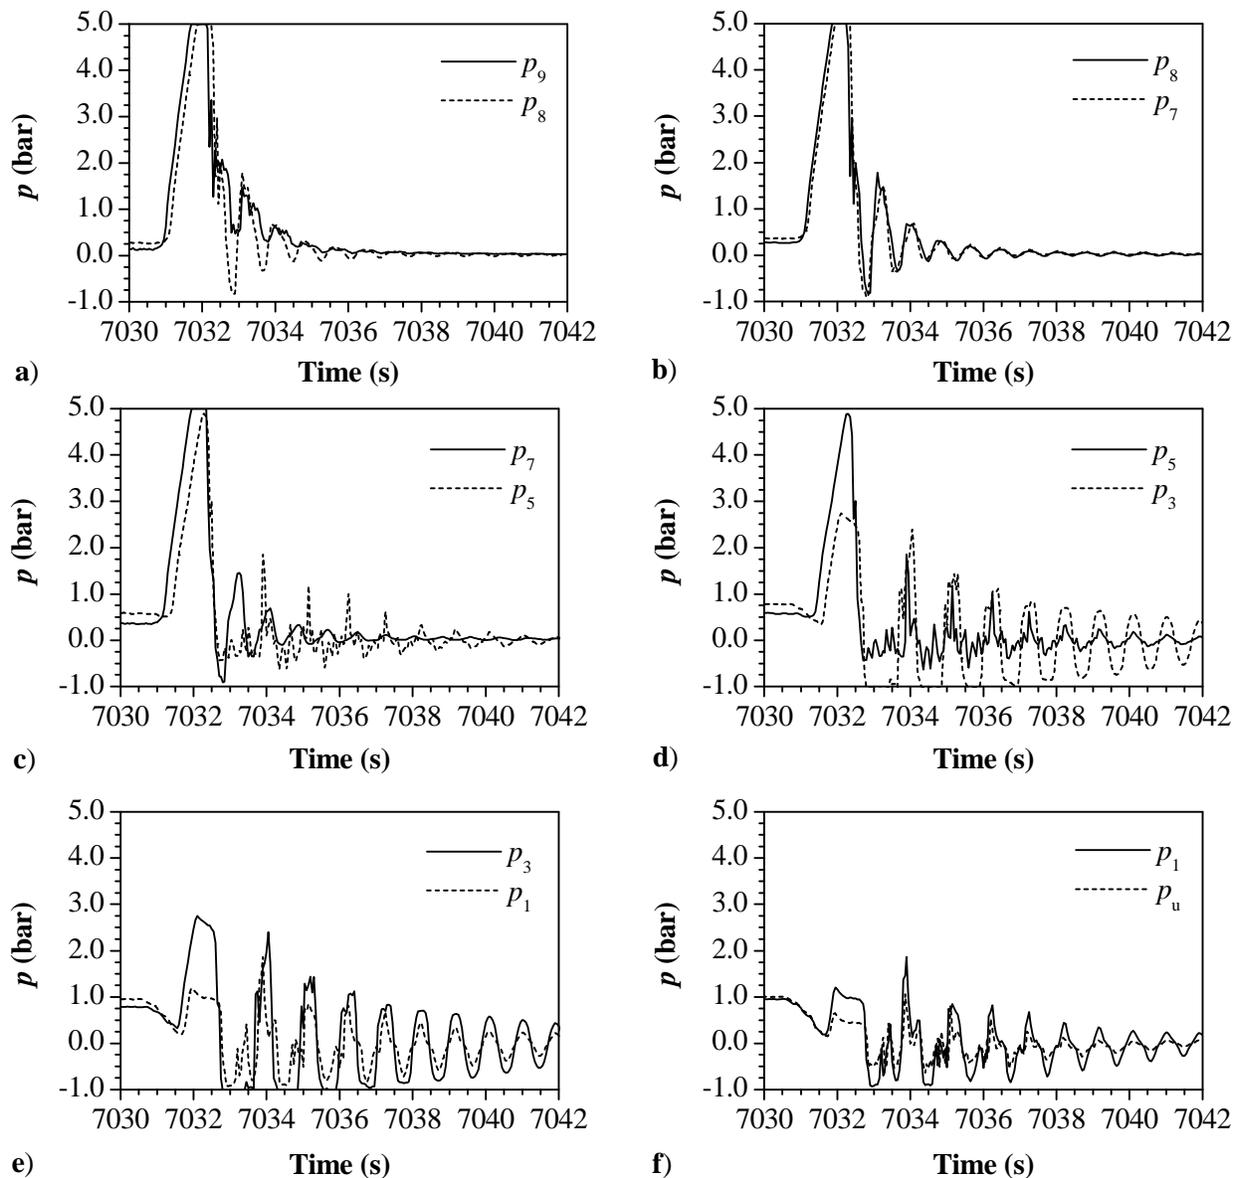
Figure 9 shows pressure histories at different positions along the PVC pipeline. From these graphs one can deduce that there were two major pressure waves in the accident: the pressure upsurge that was travelling in the upstream direction from the control valve at the outlet of the pipeline and the pressure downsurge that was travelling in the downstream direction from the control valve at the upstream end tank. Based on these recordings one may conclude that such pressures are possible only if both valves were closed almost simultaneously. The pressure upsurge travelling upstream caused damage to the piping system at various locations. Upsurge and downsurge were superimposed when they met and this is evident from the figures. Figures 9a to 9c show that pressure peak was cut-off at 5 bar. This is because experiments with expected maximal pressures well below 5 bar were performed (the set maximum for the recorded pressure signal). Extrapolation of the gradient of the rising and dropping pressure gives a rough estimate of the maximal pressure p_0 close to the outlet of the PVC pipe of about 7.5 bar (Fig. 2); however, the Joukowsky pressure rise [10] in the PVC pipeline based on the initial flow rate would be approximately 10 bar. The difference between estimated actual maximal pressure and the rough theoretical estimation is attributed to the large deformations and leakages and not to viscoelastic damping. It is worth to mention here that the PVC part of the experimental test rig was designed to withstand a

maximal pressure of 7.5 bar. Figures 9d and 9e indicate intense transient vaporous cavitation zones along an extended length of the PVC pipeline.

Figure 9: Gauge pressures in water pipeline during the accidental event.
